AFML-TR-71-104

**AN INVESTIGATION OF
VERY-HIGH-SPEED-DROP-IMPINGEMENT
EROSION OF 1100 ALUMINUM**

**Olive G. Engel
University of Dayton Research Institute**

May 1971

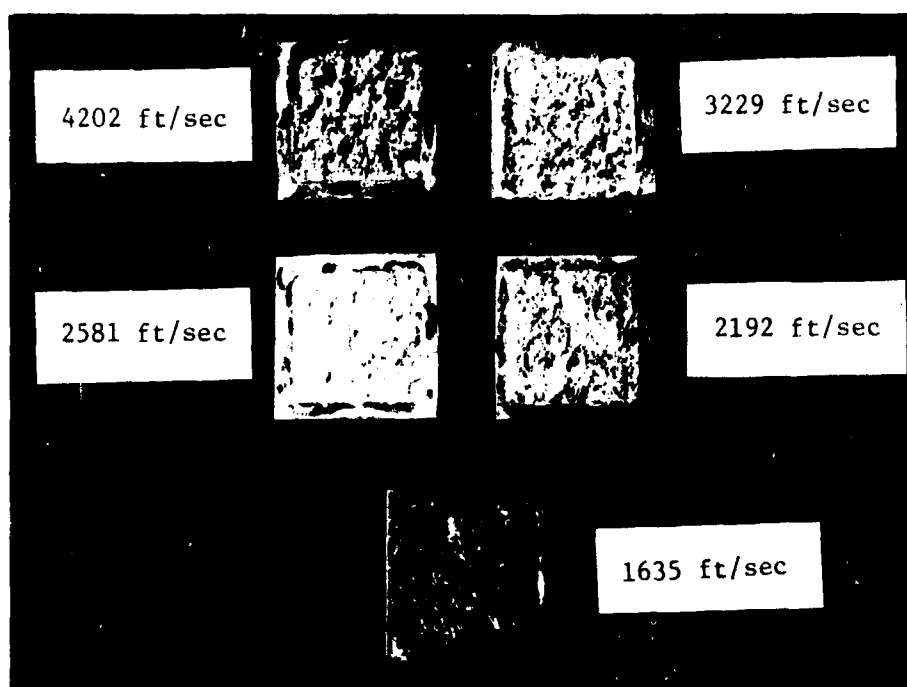
Figure 1. Specimens Tested At An Angle Of 60° . Magnification 0.7 X.

It can be seen by inspection of Figure 1 that the damage done to the specimens increased sharply as the test velocity was increased. The specimens were studied in order of increasing impingement velocity.

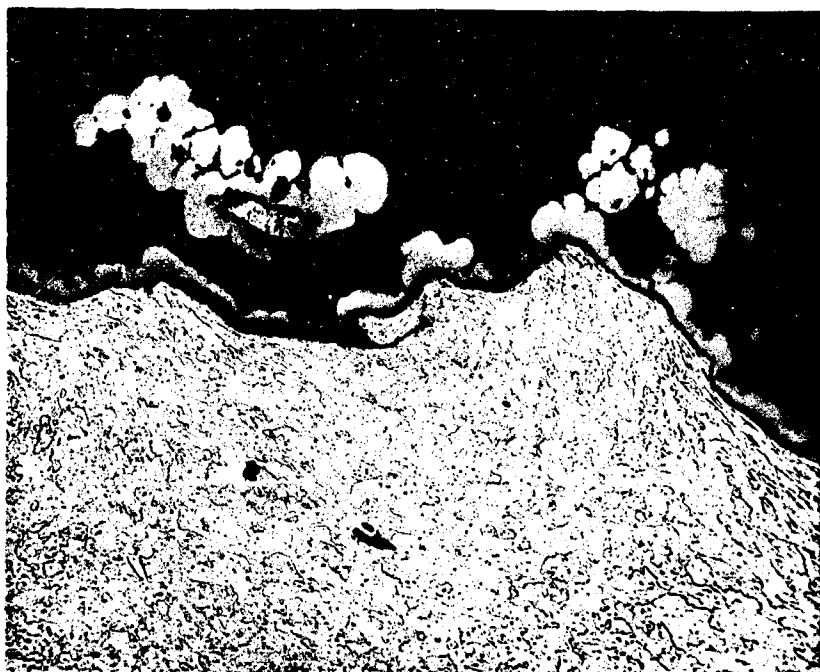
Figure 19. Plastic Flow. Test Velocity 2581 ft/sec.

Inspection at 50X of the specimen eroded at 2581 ft/sec revealed a structure that could possibly be the start of a crack. This is shown in view A of Figure 19. However, when the magnification was increased to 250X, it was clear that this structure is not a crack at all but simply protruding metal that has been flattened against the surface by the impact of drops or by the radial flow of their liquid contents. The structure is shown at the higher magnification in view B of Figure 19. The lines of plastic flow in the metal clearly indicate the origin of this structure.

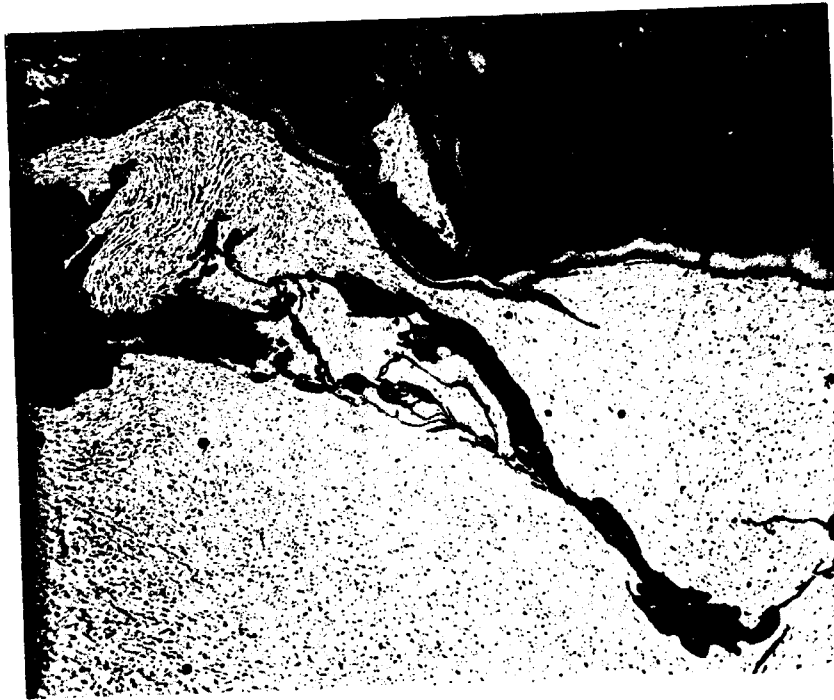
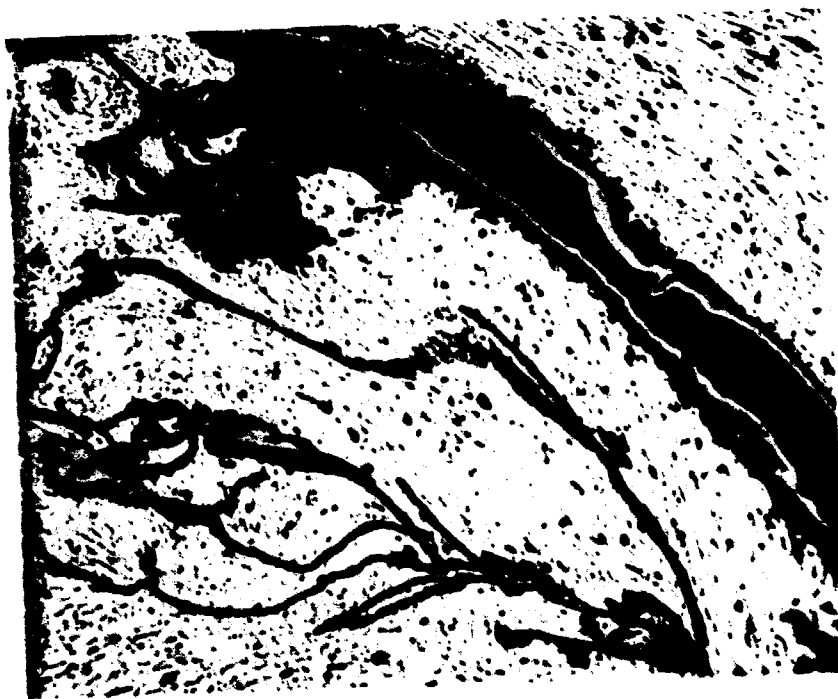
Figure 20. Plastic Flow.

Inspection of the specimen tested at 3229 ft/sec at a magnification of 50X revealed several structures that suggested crack formation. These are shown in view A of Figures 20, 21, and 22. However, when the magnification was increased to 250X the lines of plastic flow in the metal clearly indicated that the meandering black lines are not cracks but are simply surfaces of separation between masses of plastically flowed metal.
